Case Study Briefings

Africa Regional Course in Environmental Assessment and Environmentally Sound Design ■ Kabale, Uganda ■20–24 May 2002

CASE STUDY 1: Community-based watershed management for flood and erosion control

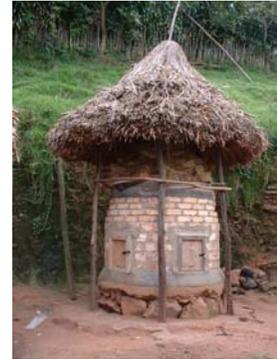
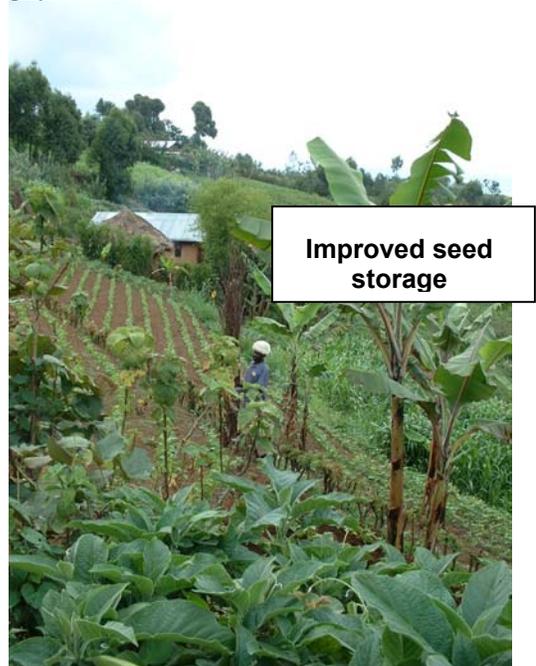
Improved seed storage

Processing and storage. Africare’s baseline survey for its Uganda Food Security Initiative found that crop and seed “storage facilities are non-existent or in disrepair and preservation methods are antiquated. The incidence of pest infestation is high” (3). Seed potatoes, in particular, require special storage facilities to avoid rot.

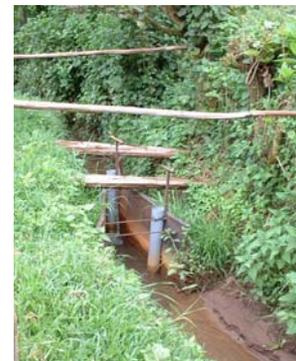
Monitoring flume

AFRENA has established 3 flumes to monitor stream flow and water quality in the catchment and is currently in transition to community-based monitoring, AFRENA believes they are seeing significant water quality improvements and stream flow moderation in the watershed.

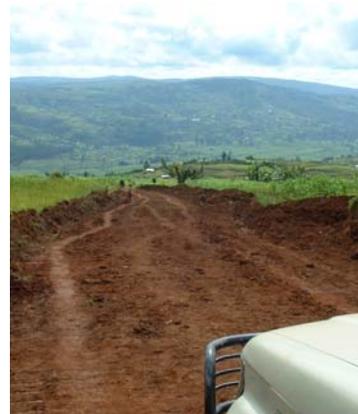
Looking downslope on a newly cut Africare community road

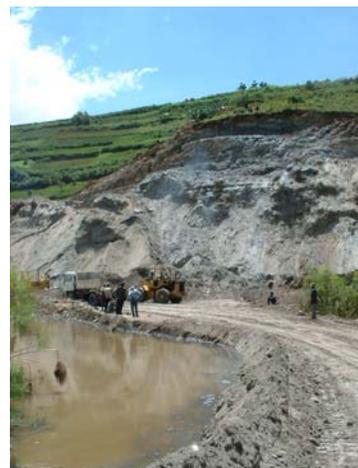
Excavation of roadbed material from hillside for cross-wetland traverse

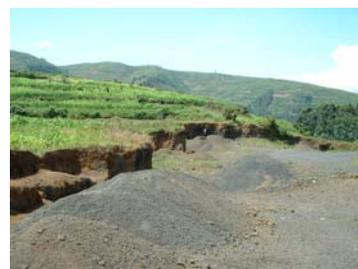
Lava ash mining

In travel to the Krone (U) Ltd access road, participants will pass by a small-scale lava ash mining site (photo). The site illustrates many of the issues associated with borrow sites for road materials.
